TO: Paul Skubinna
FROM: Carter Avery, EIT
CC: Carter Avery, Ross Hanson
DATE: May 2, 2025
RE: Glasgow Terrace/Hurley Drive Water & Sewer Main Replacement

RPR Summary – April 28, 2025 through May 2, 2025

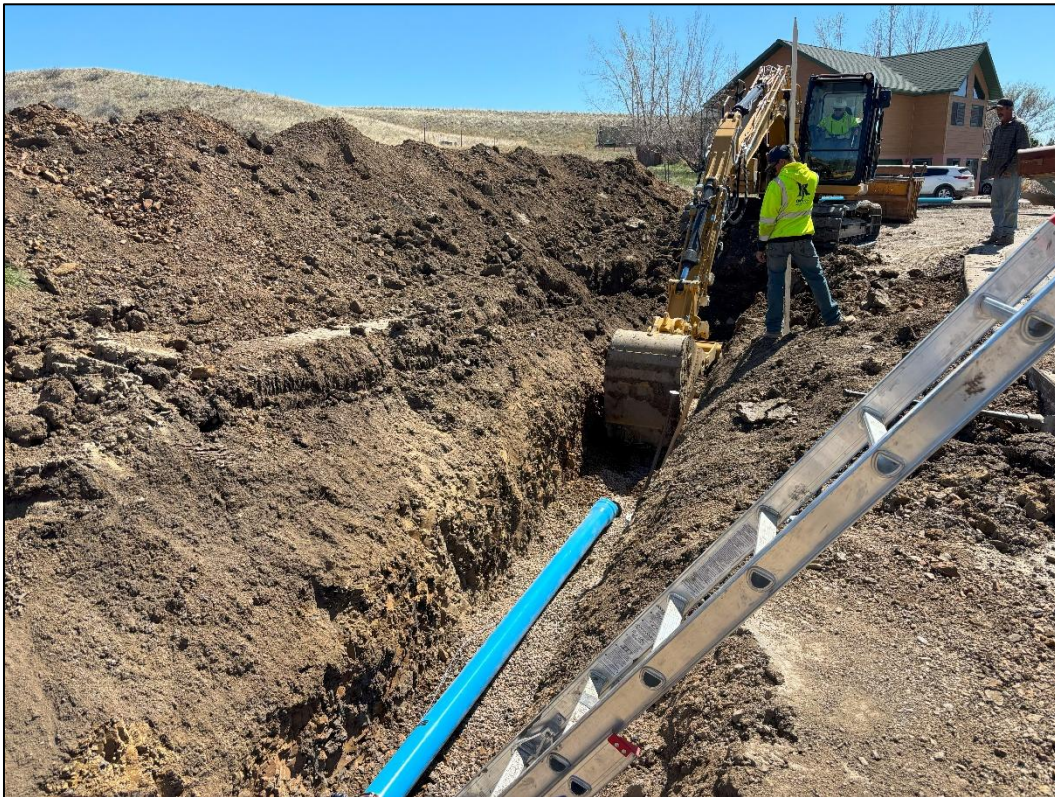
Figure 1: Water main trenching in Hall Terrace.

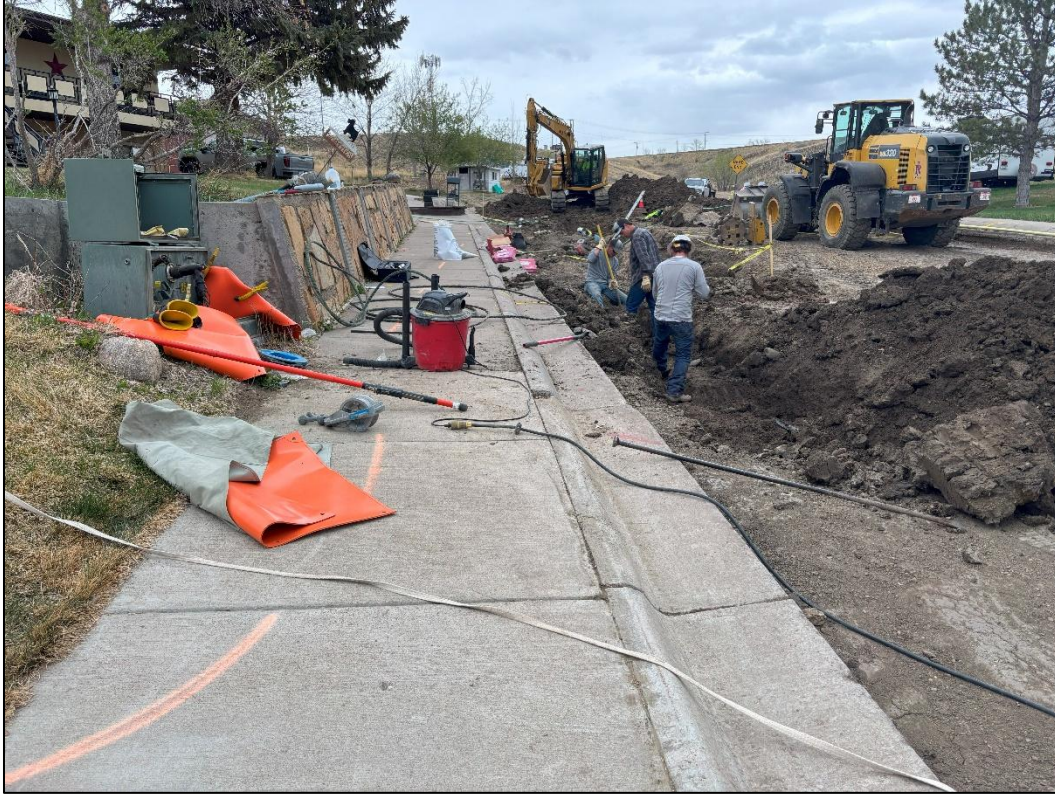
- JR Civil worked on:
 - Installation of 6" C900 water main on Hall Terrace from station 9+00 to station 12+00.
 - Electrical line repair work on East Hurly Drive by NorthWestern Energy.

Figure 2: Repairing electrical line on East end on Hurley Drive.

- JR Civil Worked on installation of 6" C900 water main, service saddles, valves and fittings in Hall Terrace and Hurley Drive.
- Damage to electrical line on East end of Hurly Drive repaired.
- Damage to fiber optic line near station 6+10 on Hall Terrace repaired.

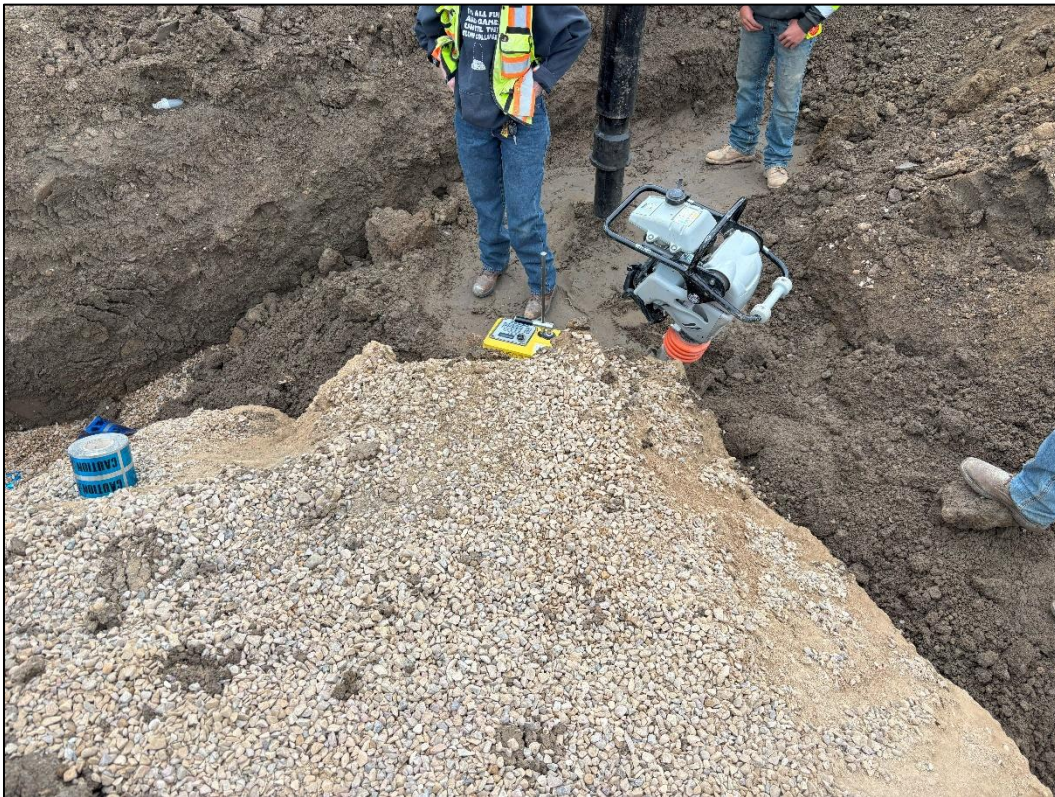
- Installation of water service saddles near stations 11+00, 8+50, and 7+00.
 - Density tests were performed on Hall Terrace. Testing company reported passing tests.

Figure 3: Density testing on Hurly Drive.

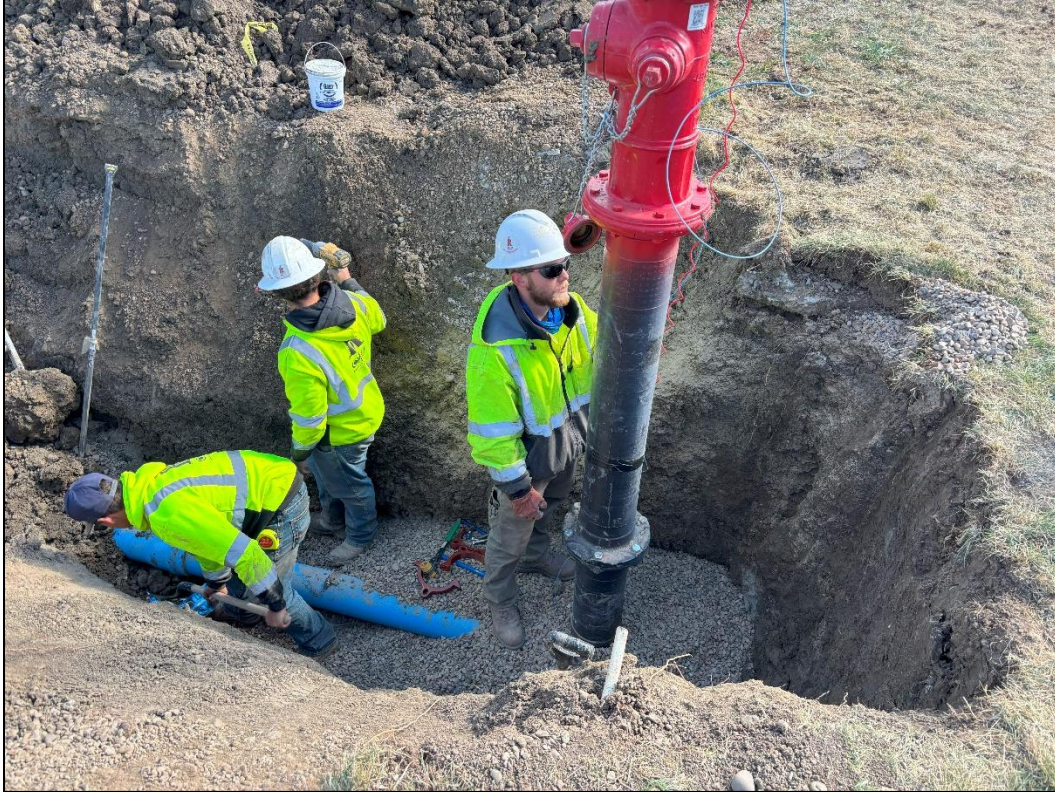
- Monday, April 28, 2025
 - JR Civil worked on:
 - Installation of 6" C900 water main on Hall Terrace from station 12+00 to station 13+15,
 - Installation of north Fire Hydrant on Hall Terrace near station 12+90 and,

Figure 4: Fire Hydrant installed on Hall Terrace.

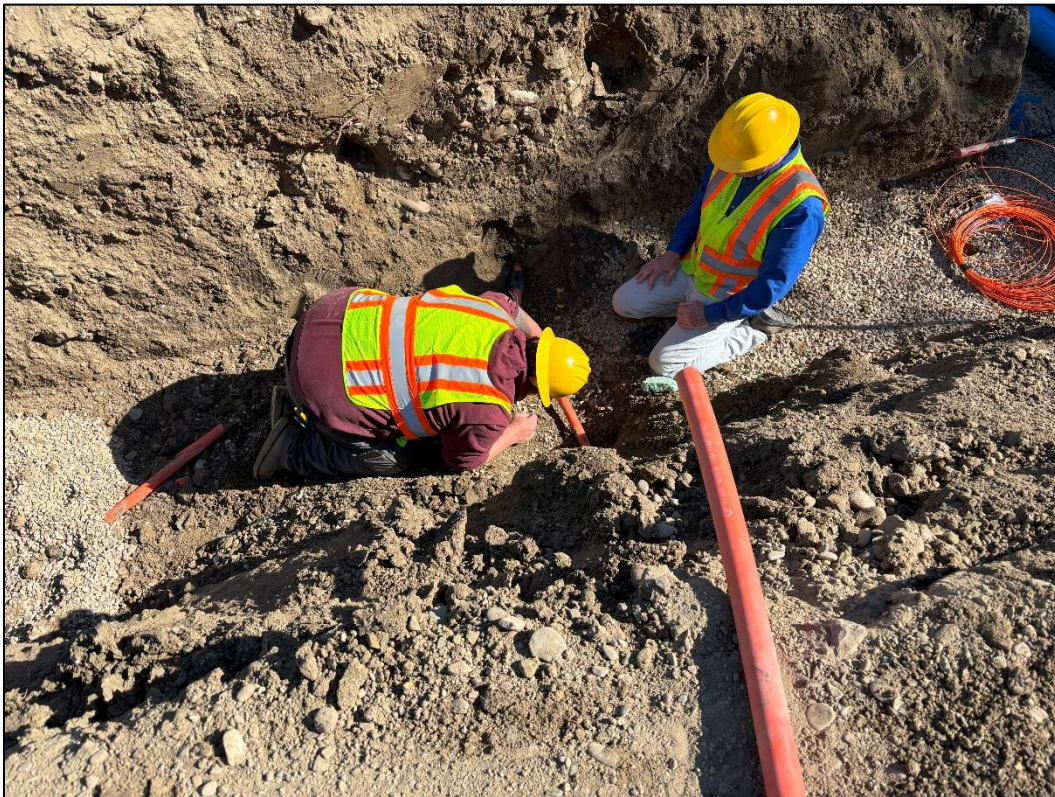
- Friday, May 2, 2025
 - Jr Civil worked on:
 - Installation of 6" C900 water main on Hurly Drive from station 5+25 to station 6+25,
 - Installation of a 6' gate valve near station 5+25,
 - Fiber optic line was struck at station 6+10 on Hall Terrace, repairs were made by the supplier.
 - AE2S on-site and observed work progress.

Figure 5: Repairing Fiber optic line near station 6+10.

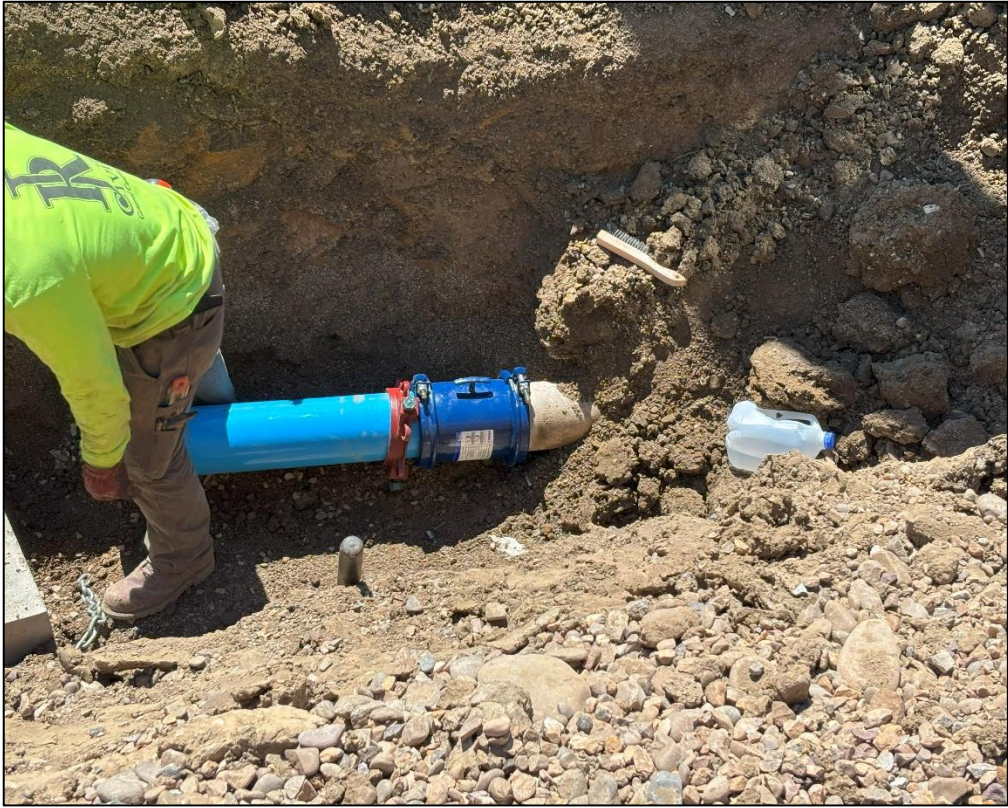
Figure 6: Connect 6" water main pipe to existing water main on Hall Terrace.
